1970 LIGHTNING AND STATIC ELECTRICITY CONFERENCE, 9-11 DECEMBER

AIR FORCE AVIONICS LABORATORY

SOCIETY OF AUTOMOTIVE ENGINEERS

Information is presented on lightning and static electricity phenomena from the standpoint of their relation to, and interaction with, aerospace vehicles and ground complexes. Interactions and the effects of lightning and static electricity on electrical, electronic, structural, static discharger systems and fly-by-wire systems of aerospace systems are described. The information presented is considered to be of interest to scientists and engineers in the fields of electronics, advanced composite materials and structures, and atmospheric electrical phenomena.

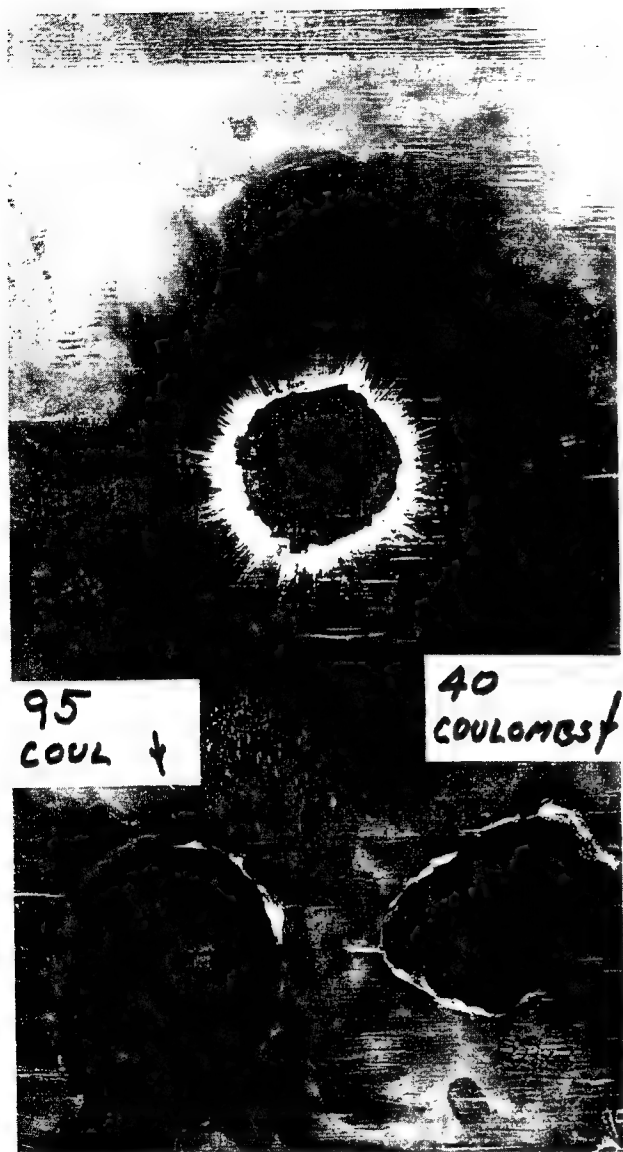
Fig. 3 - Panel B-3 (boron fiber epoxy) after exposure to 100 kiloamps (100 kiloamp discharge at top center - 95 coulomb and 40 coulomb discharges at bottom of panel were done later).

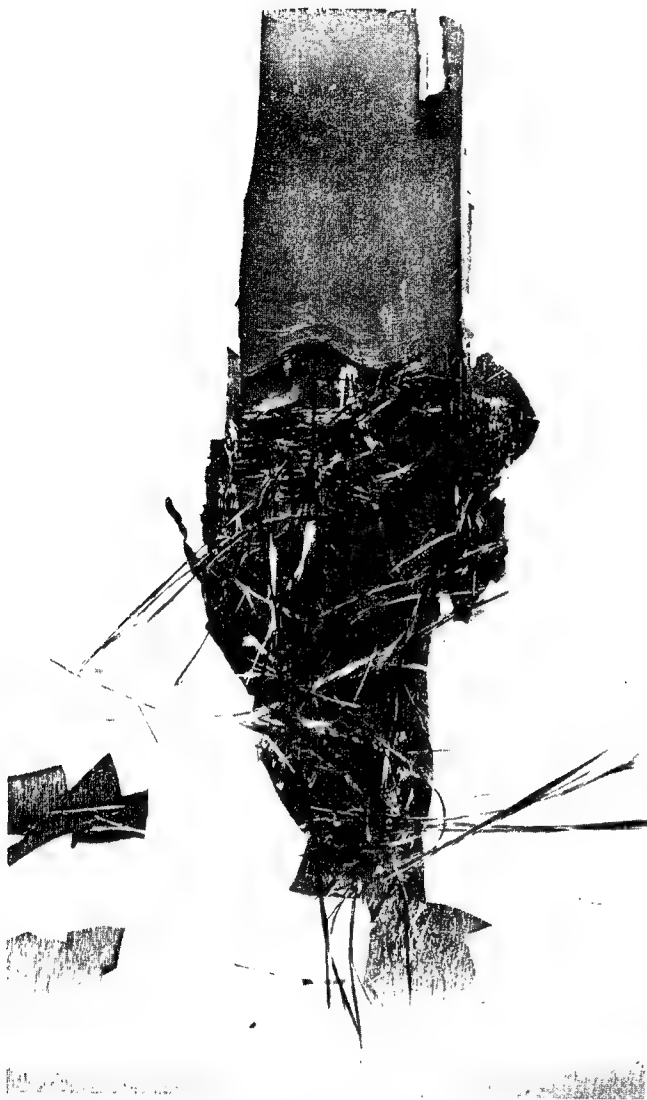
Fig. 7 - Front surface of panel G-10 (coated with potassium oxalate filled acrylic paint) after exposure to 85 kiloamps.

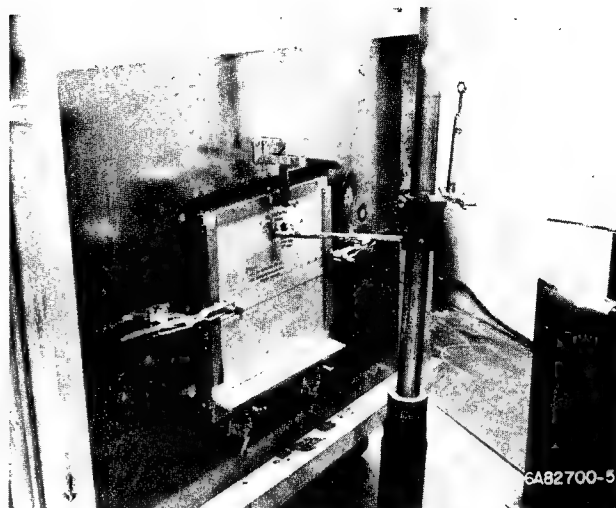
Fig. 16 - Laboratory setup for exposing test panels to simulated lightning strikes.

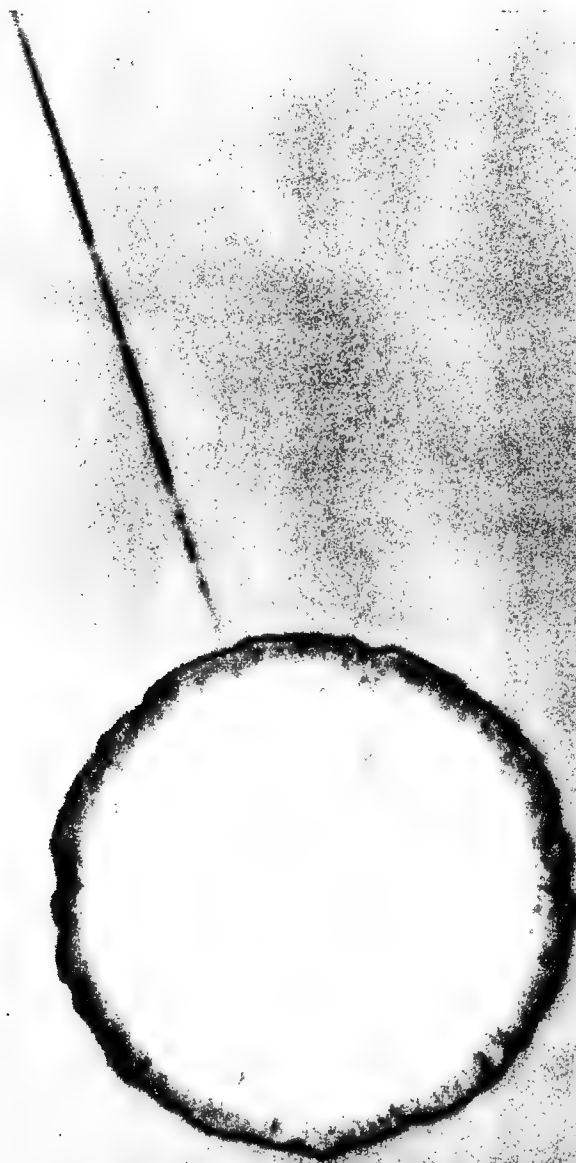
Fig. 23 - (2000X) View of damaged boron filament (BU #26) that has been etched but does not show evidence of melting

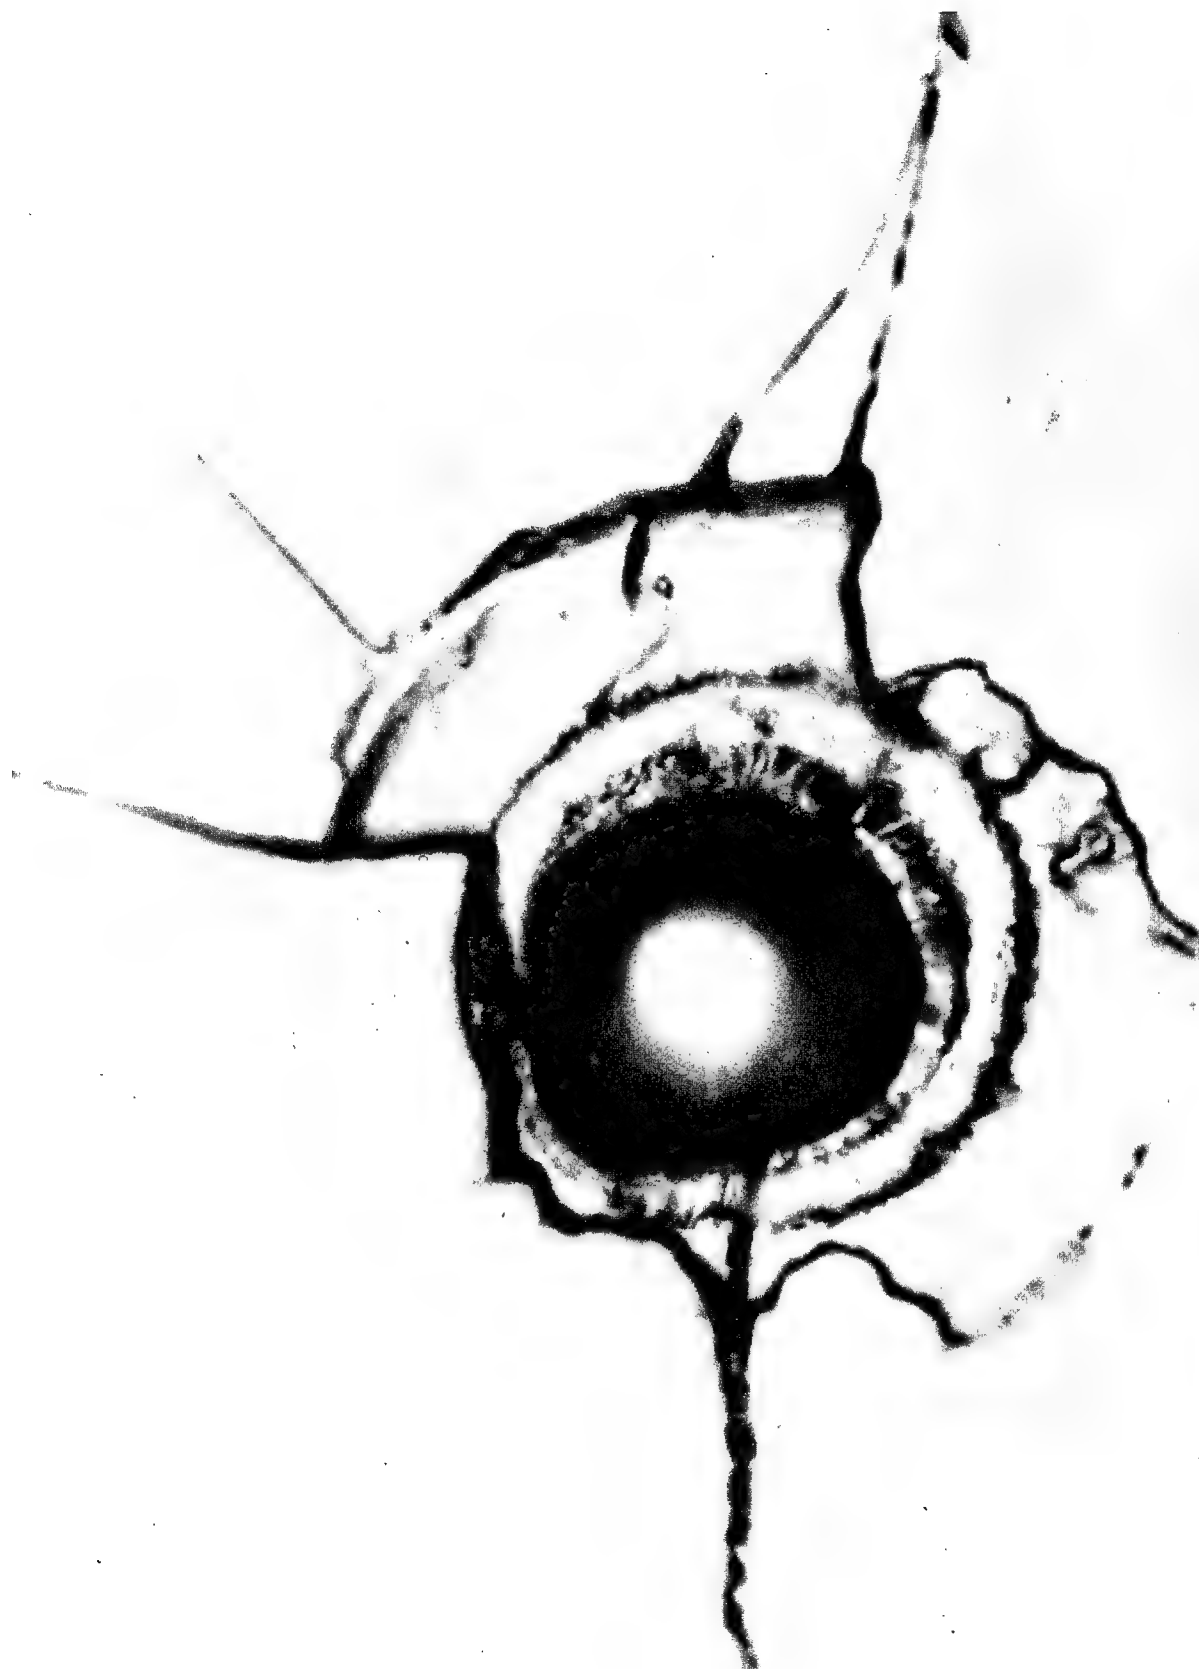
Fig. 24 - (2000X) View of boron filament in BU #26 composite where major portion of the core has been lost due to melting or vaporization

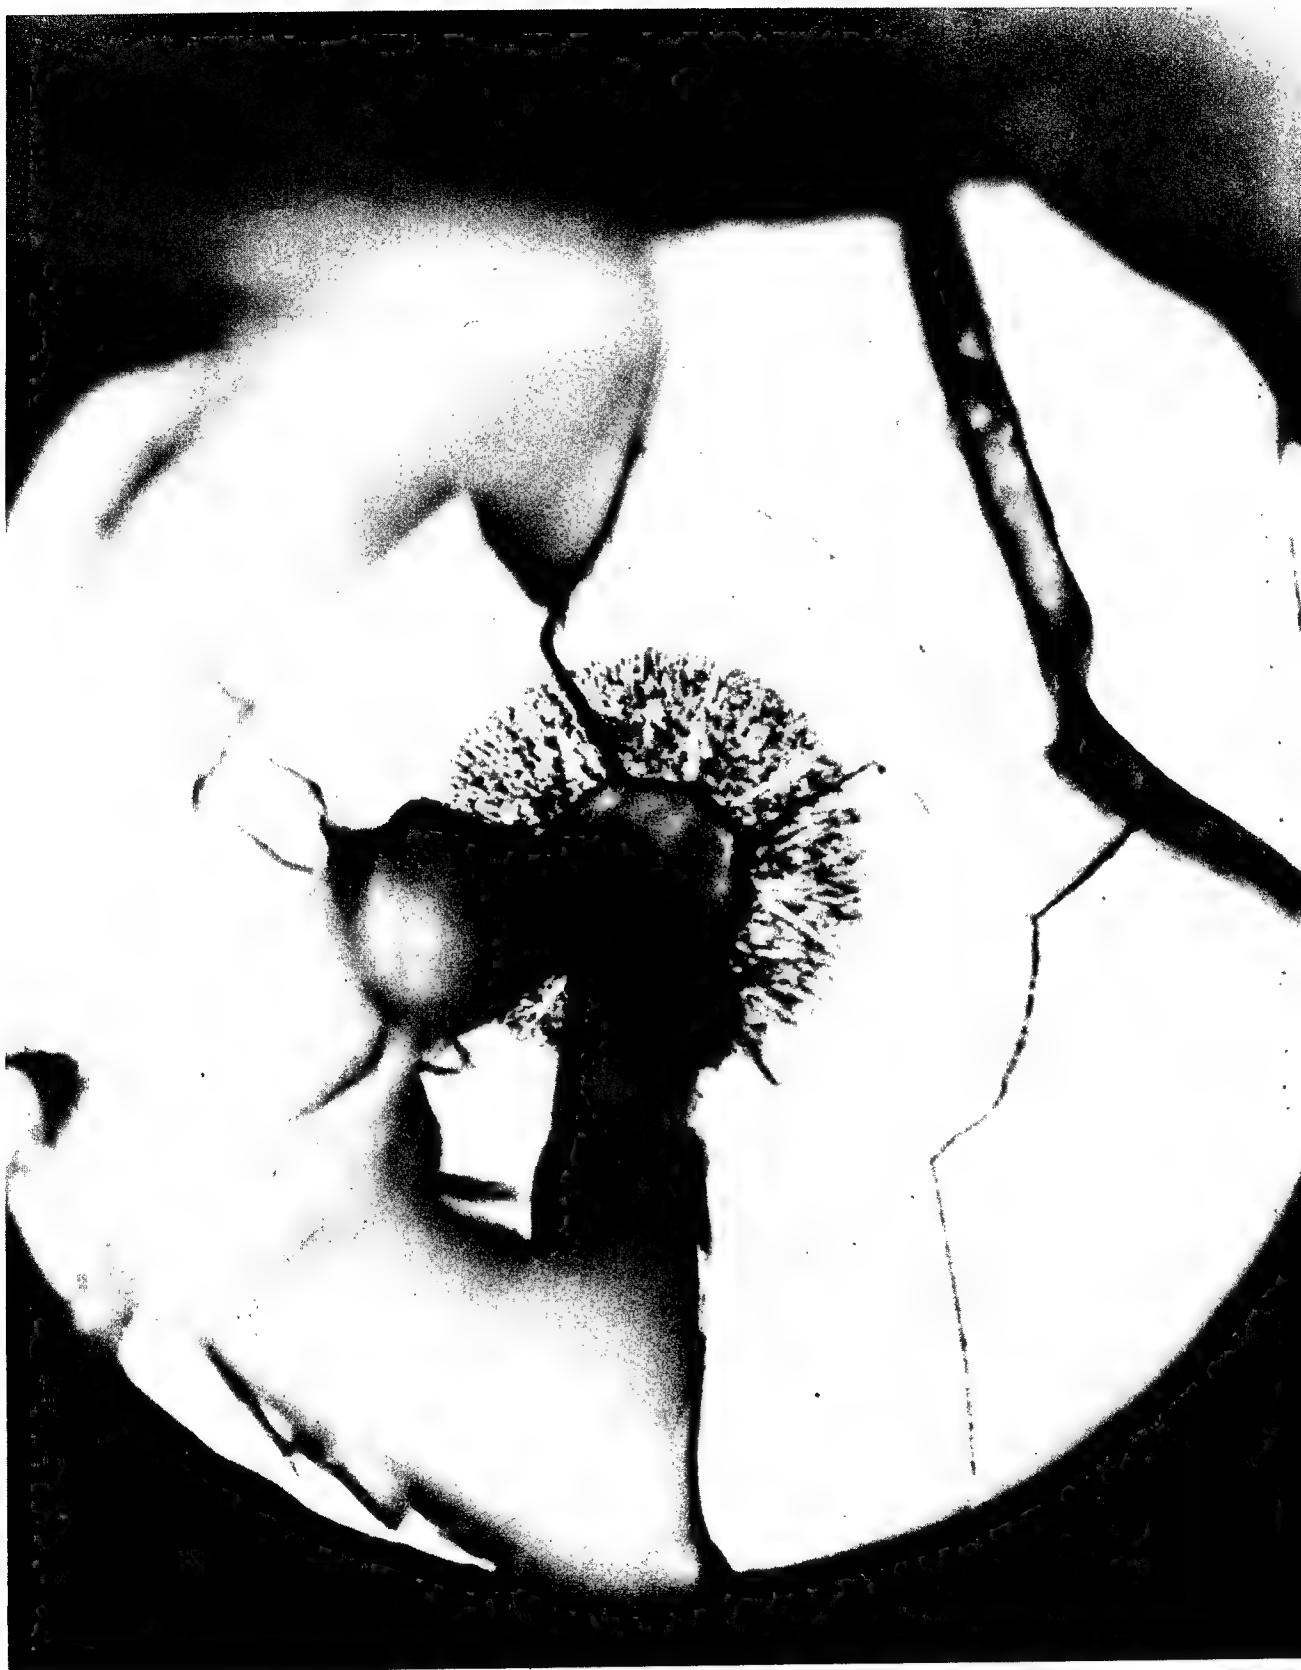
Fig. 26 - (800X) View of electrically damaged boron filament in composite specimen BU #13

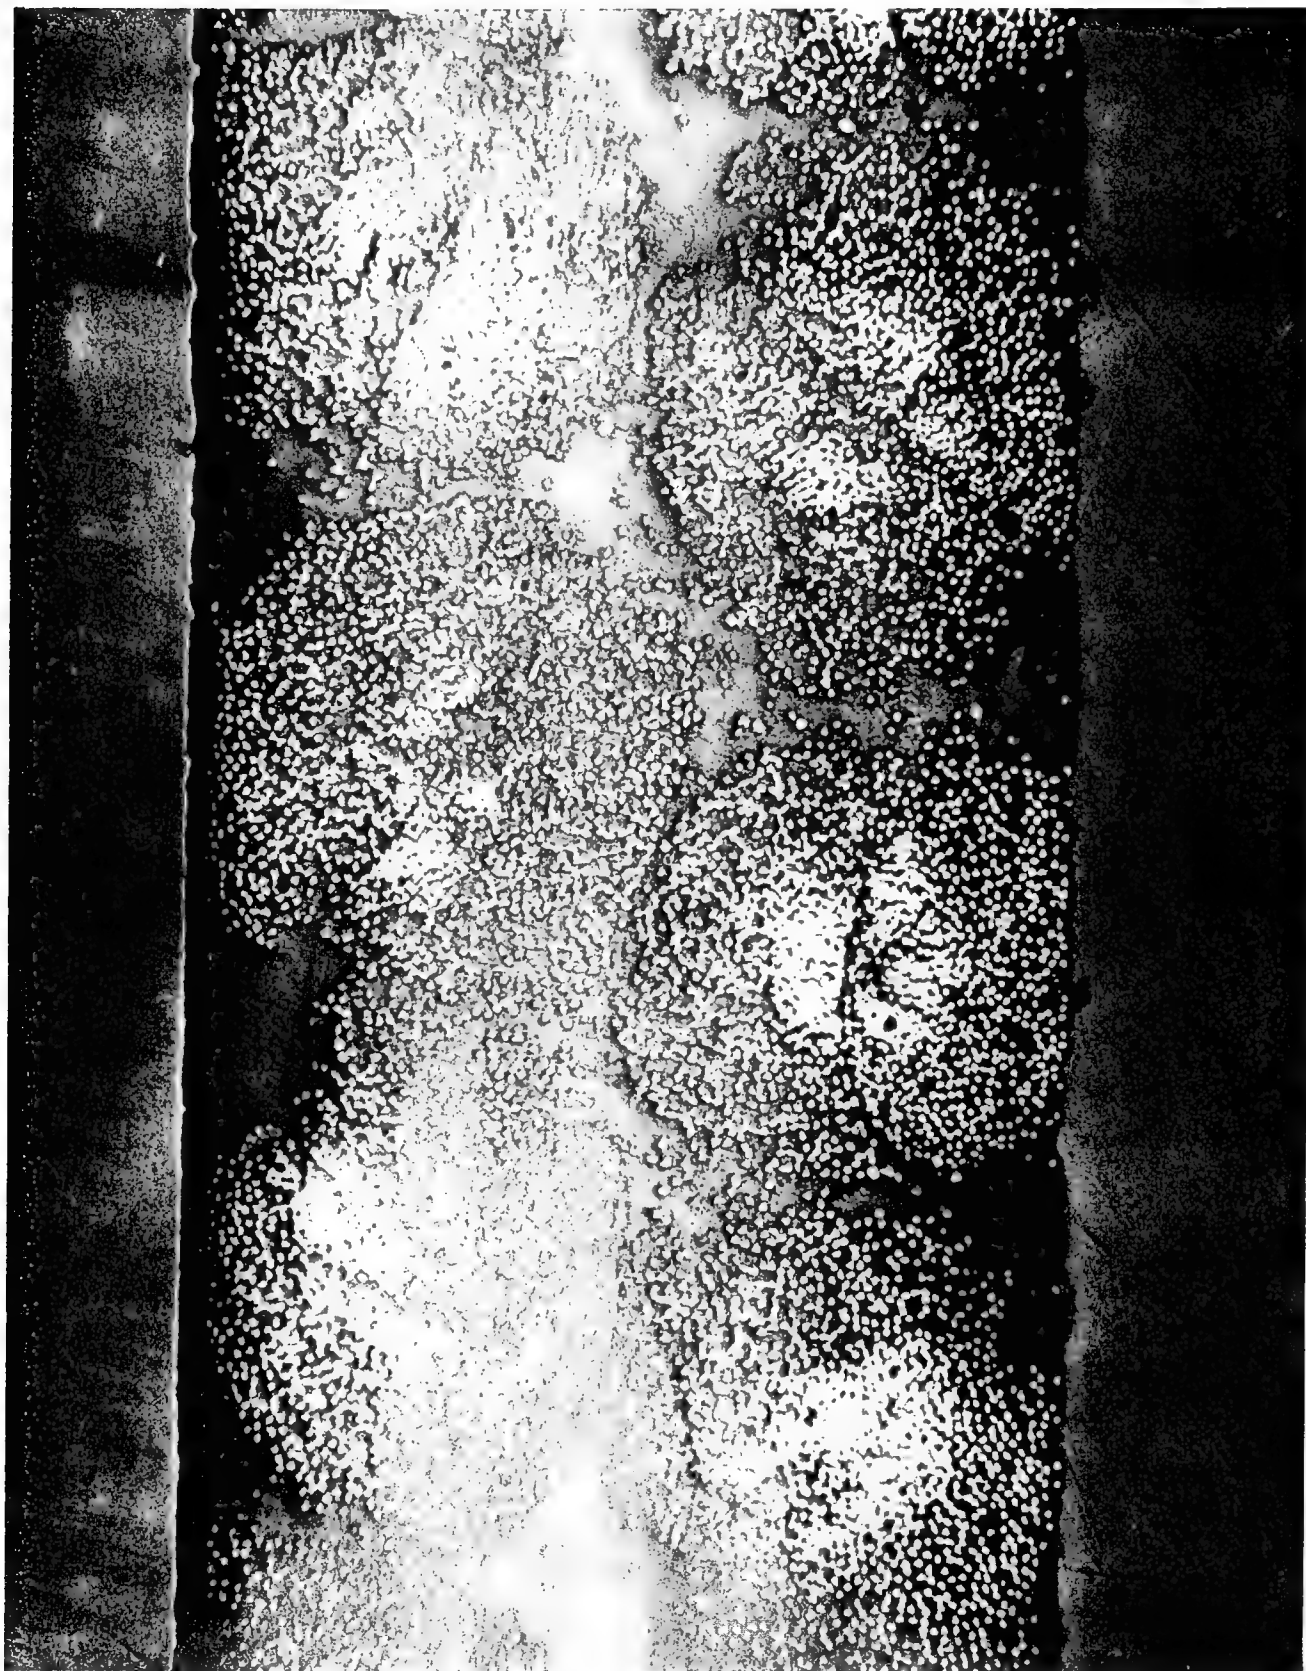
Fig. 30 - (100X) HMG-50/epoxy specimen after 13.04×10^4 amperes per cm^2 of filament crest current injection--no damage

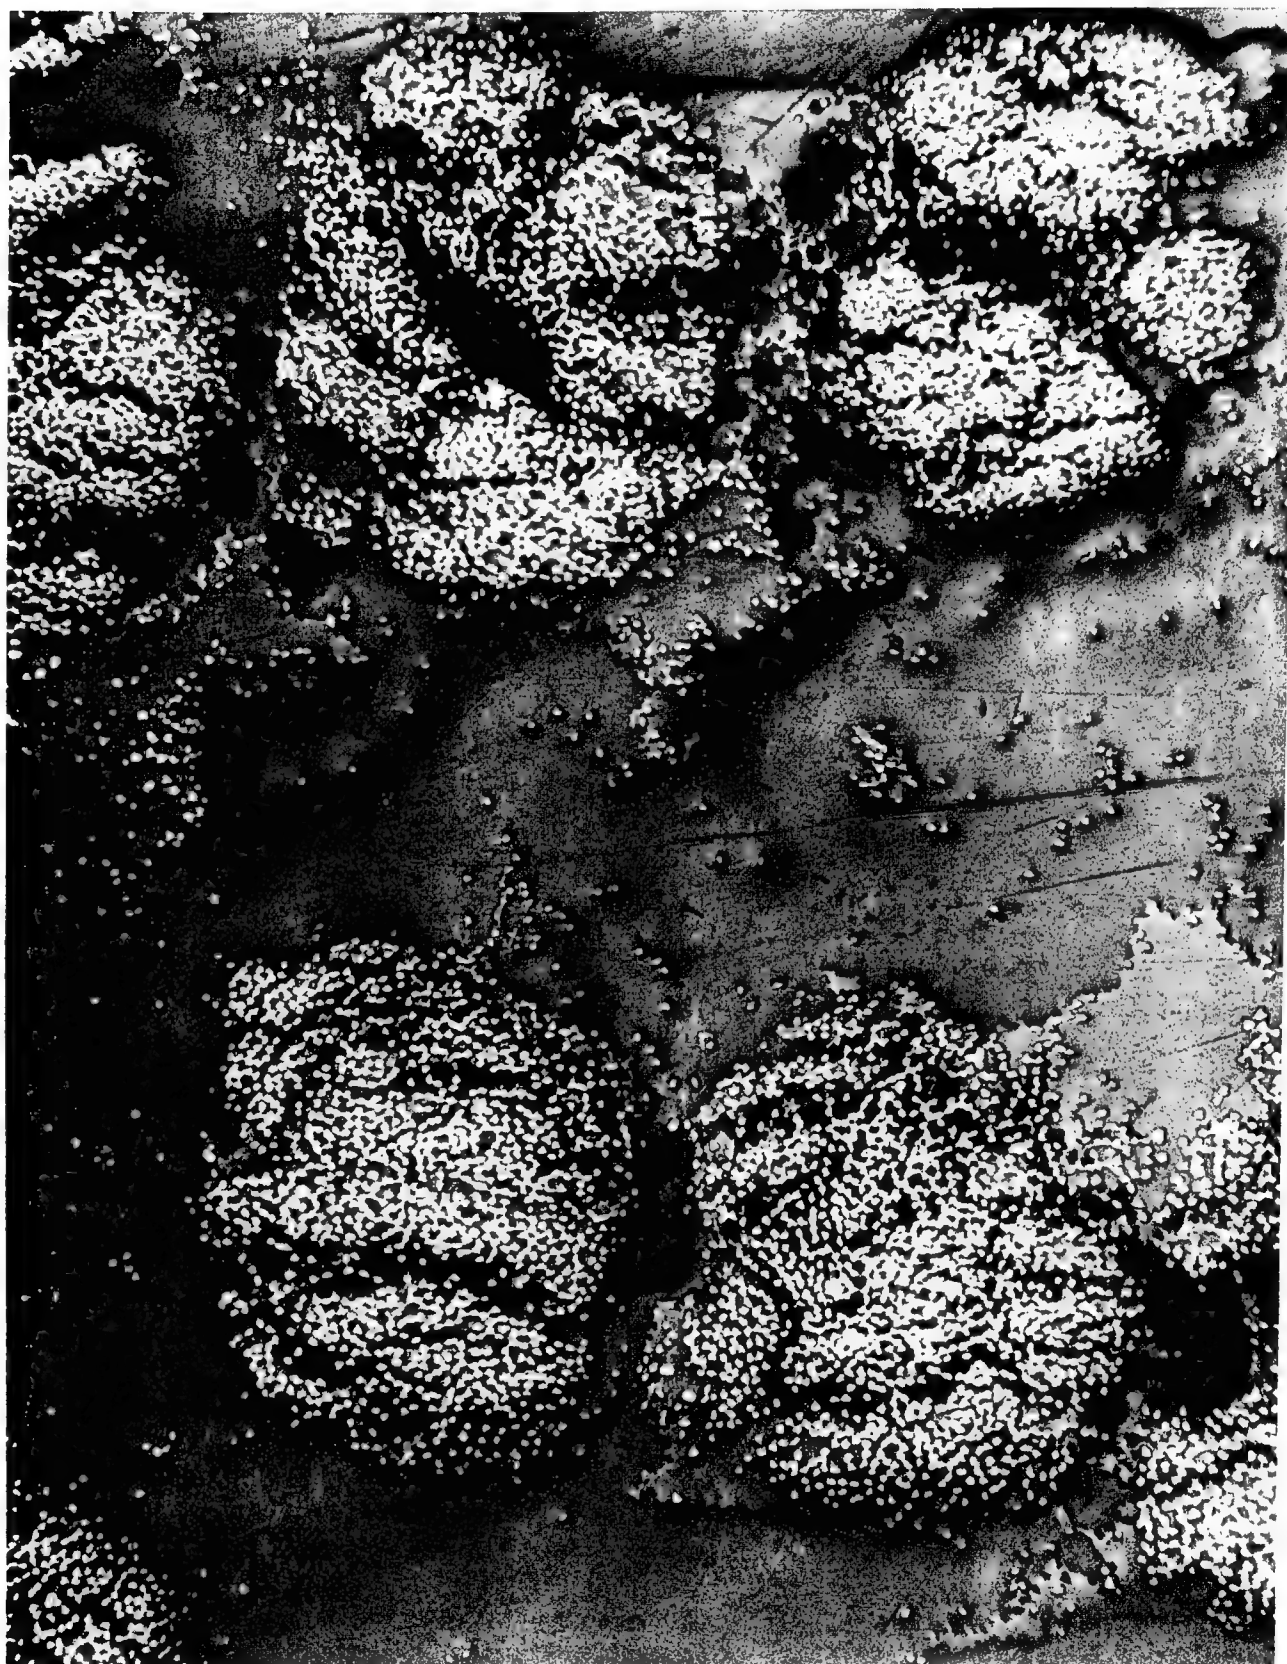
Fig. 33 - (100X) HMG-50/epoxy specimen after 55.8×10^4 amperes per cm^2 of filament crest current injection--severely burned and delaminated

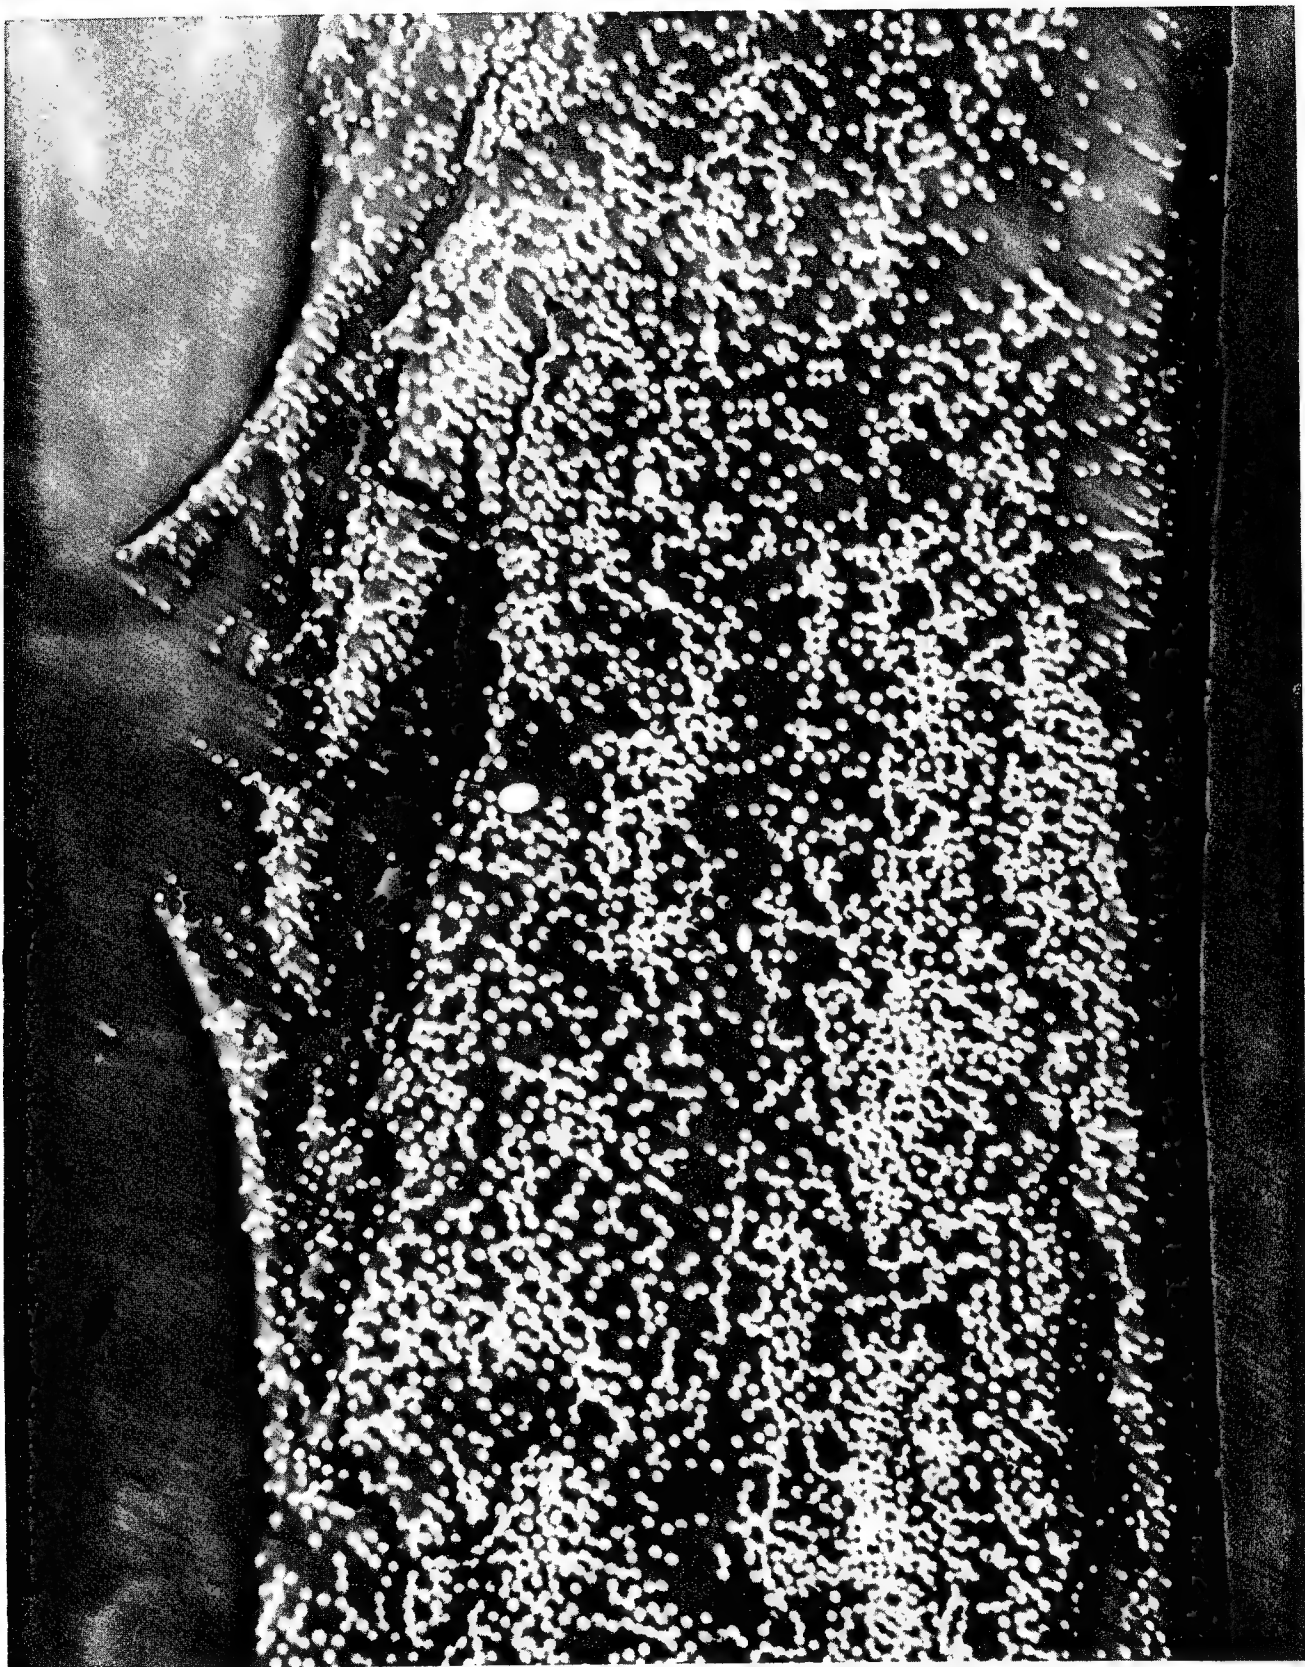
Fig. 37 - (100X) HM-S/epoxy specimen after 25×10^4 amperes per cm^2 of filament crest current injection--some burning and delamination
